CWF FARMER PROFILE: Craig & Carol Blocksome

Ness County

Dry Bazine Creek Upper Arkansas River Watershed

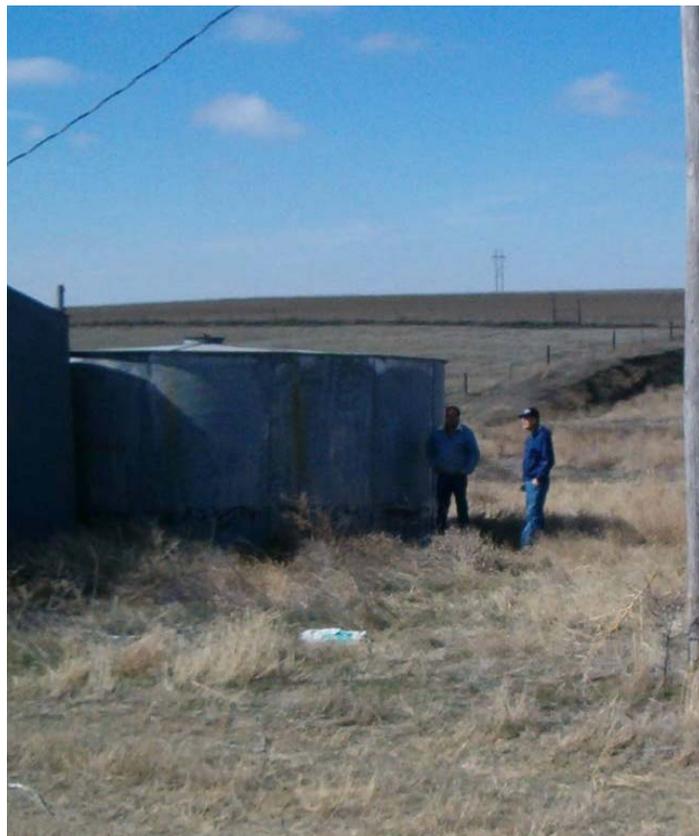
Craig Blocksome, Ransom, and Clean Water Farms Field Organizer Troy Schroeder, discuss the above ground tank that held livestock waste from the Blocksome's former hog operation. With CWFP cost-share, Blocksome removed the tank as well as a below ground tank and recycled them.

“Anytime you have something like that, eventually it’ll rust down and manure may leech out into the soil,” Craig said. The Blocksomes were concerned that the contamination, if it occurred, could reach the water table or Bazine Dry Creek which runs through the farm. “The waste tanks posed a continued water quality threat if leaks were to develop over time and allow waste into the water table,” Troy said.

Craig then scraped the area around each of the tanks and backfilled the hole caused by the removal of the buried tank. Grass seed was sown into the bare areas to stabilize the soil and reduce erosion from runoff. After removing the tanks, he extracted the remaining manure and spread it on his crop ground. Craig then cut each tank into pieces and took it to the salvage yard to be recycled as scrap steel.

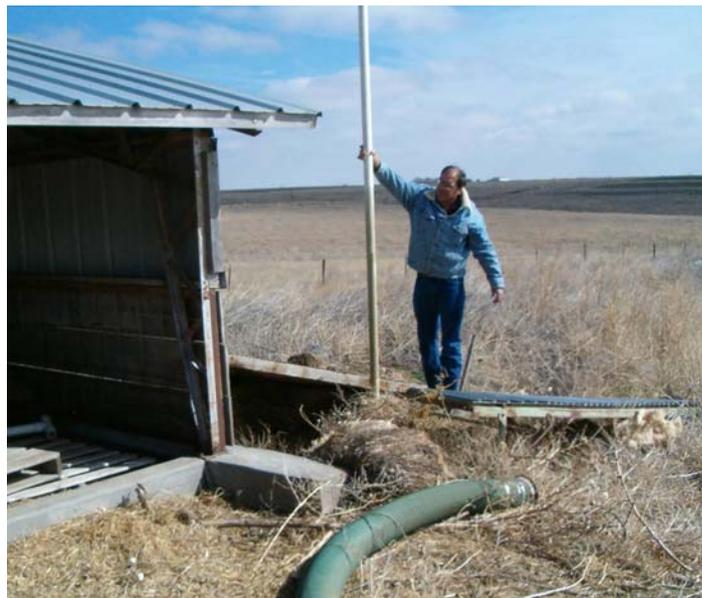
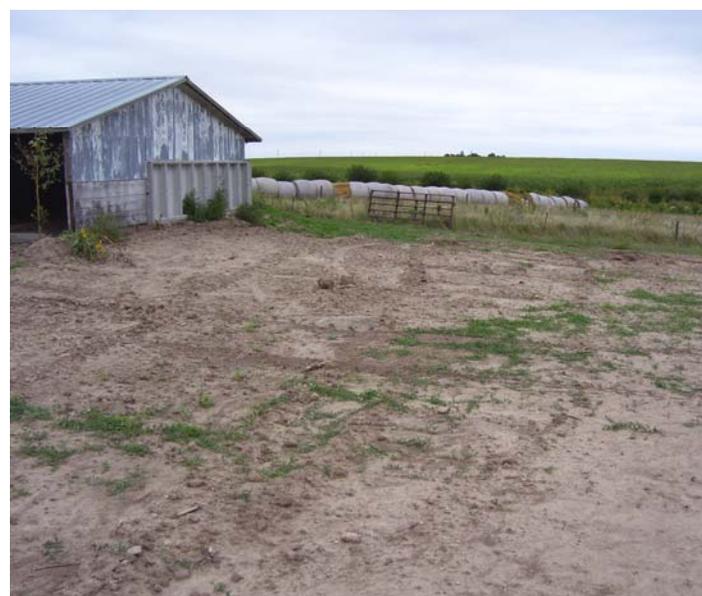
BEFORE (top): Craig Blocksome inspects the abandoned livestock waste tank buried on his Ness County farm. **AFTER (bottom):** After the tank was removed and recycled, the site of the former tank has now been seeded to grass.

To ensure that the soil under and around each tank was not affected by manure, which is typically loaded with nitrates, soil testing was done this spring. “Soil testing was done at each tank site to confirm that no significant leakage had occurred,” Troy said. “Soil tests were well within tolerance so no soil treatment was necessary.”

While completing the project, Craig said the biggest obstacle was getting the buried tank out of the 14’ hole. He said the removal took several attempts. “I ended up putting a lot of time in on this deal,” he said. After using a backhoe to dig around the tank, a ramp was built out of the hole. Craig and a neighbor attempted to roll the tank out of the hole using a tractor. After several failed attempts, eventually the neighbor’s Steiger four-wheel drive tractor and a substantial tow rope (normally used to tie submarines to the dock) succeeded in getting the tank out of the ground.
