## CWF FARMER PROFILE:

# John Rempe

## Nemaha County

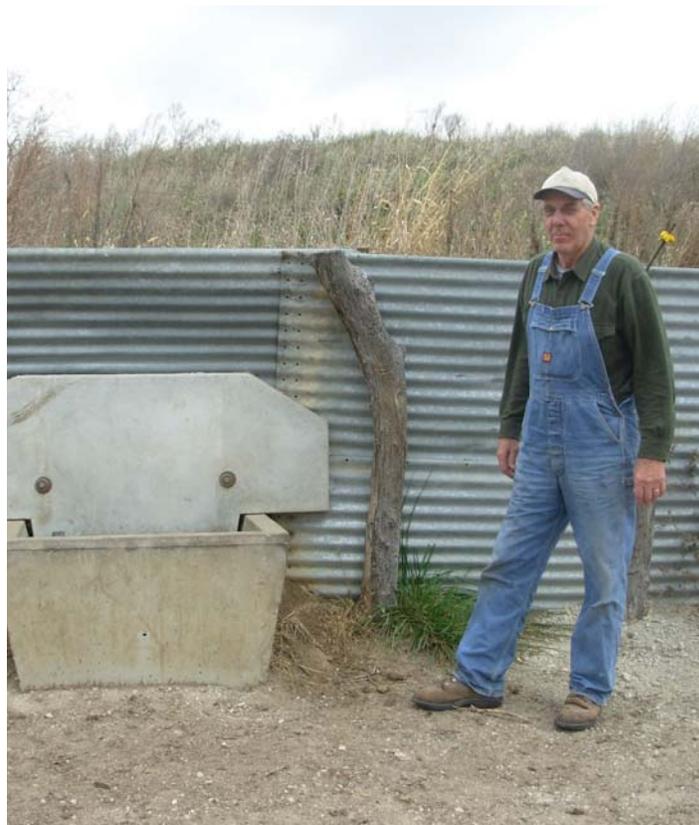
*John Rempe stands by the waterer he installed below his pond using CWF-RFFP cost-share funds. John also fenced the pond, eliminating the cattle from contaminating the water and reducing erosion to the pond's banks.*

The Rempes also addressed water quality on the property along Vermillion Creek. In this particular pasture, the cattle used a pond as their primary water source. John said he "wanted to put a waterer in and clean the pond out." John said he can see a difference in the pond water. "It isn't mucky—it is clear," he said. And the cattle seem to see the difference as well. "They drink there before they go to the creek," he said.

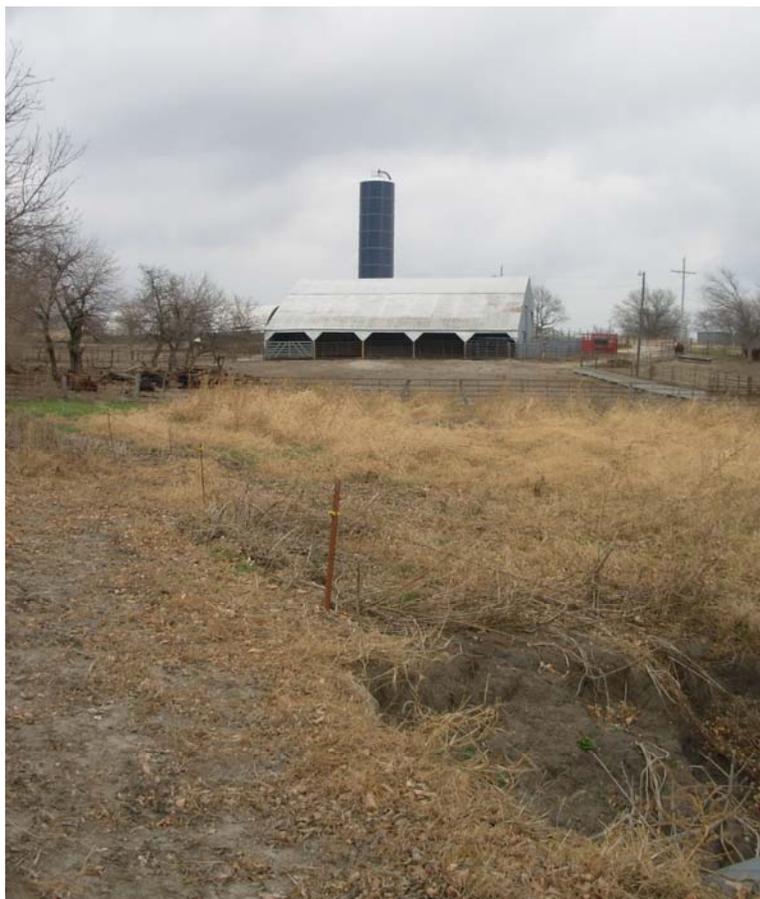
**TOP:** John Rempe moved the lot back from the creek and planted a brome filter strip to help remove nutrients from runoff. He also installed a creek crossing and fenced the creek as shown in the foreground. **BOTTOM:** The sediment basin on John Rempe's farm detours the runoff from the lot. The runoff is filtered through PVC pipe and then three acres of grass before reaching the creek below. Photos by Connie Pantle

As they often were years ago, some of the buildings and lots on John's farm were built near a creek. To comply with the renewal of his Kansas Department of Health and Environment (KDHE) livestock waste permit, John needed to move his lot further away from the creek. John uses the lot as a calving pen for his 130 cows.

"The concern was the amount of water coming off the building and crossing the lot," John said. By crossing the lot, the rainwater then becomes contaminated by the livestock waste in the lot. A grass buffer strip would filter the nutrients out before reaching the creek. Therefore, John installed a buffer strip of brome between the lot and the creek, which is a tributary to the South Fork of the Big Nemaha River.

In addition, John said he wanted to "keep the cattle out of the creek and keep the water clean." To accomplish this, a tube was installed in the creek to serve as a crossing for the cattle. The creek was then fenced to exclude the cattle. The cattle now rely on a waterer up the hill constructed from a recycled earthmover tire. Since the cattle are kept away from the creek and unable to use the trees as cover from winter winds and storms, he offers a windbreak in the form of a large bundle of recycled tires.

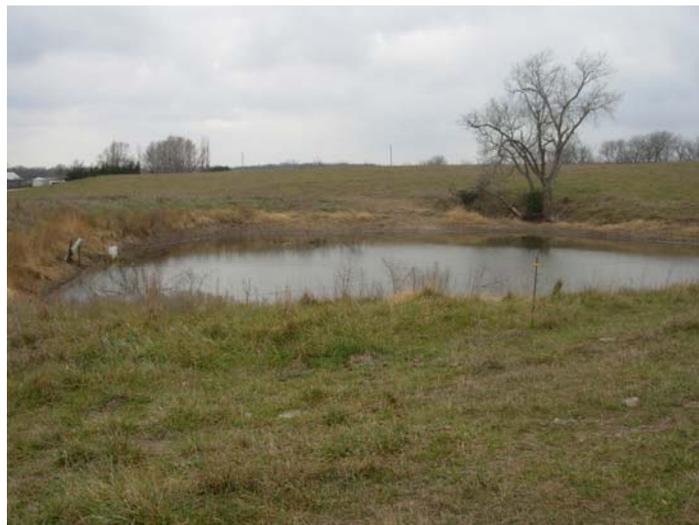
**TOP:** John Rempe's fenced pond, which has a cattle waterer below the dam. **MIDDLE:** Bundled recycled tires serve as a windbreak for the cattle. **BOTTOM:** The alternative watering site John installed features an earthmover tire. The cattle use this as their source of water as they are excluded from the creek.

The pond project was not without obstacles however. After the completion of the work, John said the pond would not hold water. While the pond was nearly empty, bentonite was applied to the pond basin. John is optimistic about the solution as the pond is now about half full.
